The Air India Express IX1344 accident at Khozikode and the ensuing investigation will focus on the deceleration devices of the aircraft, their effectiveness, the prevailing environment and the interaction with the runway surface.

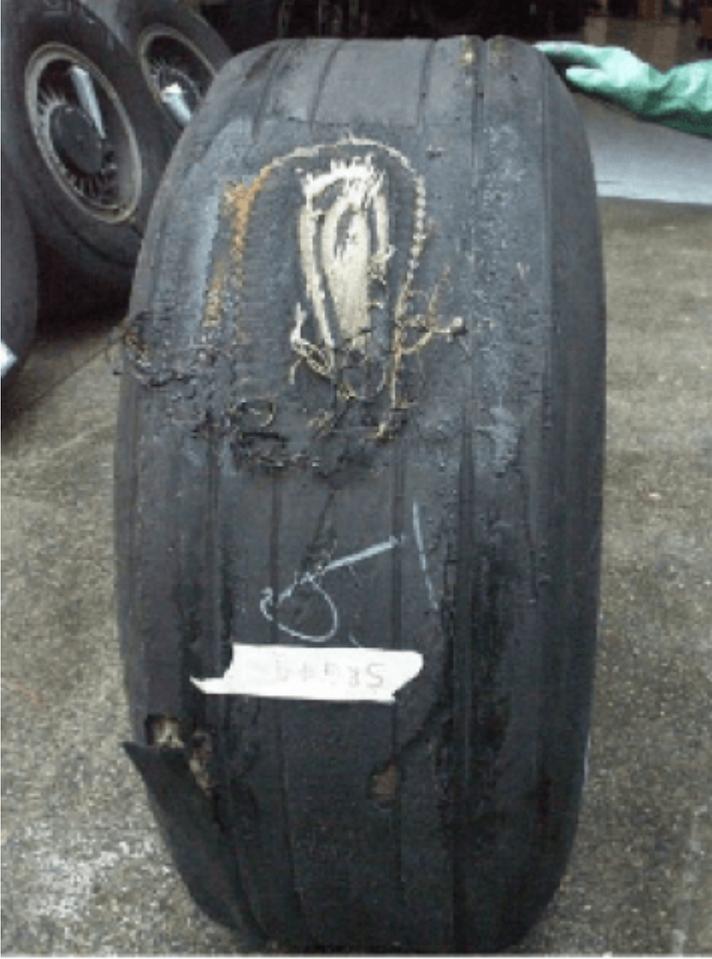
Singapore Airline hydroplaning incident tire

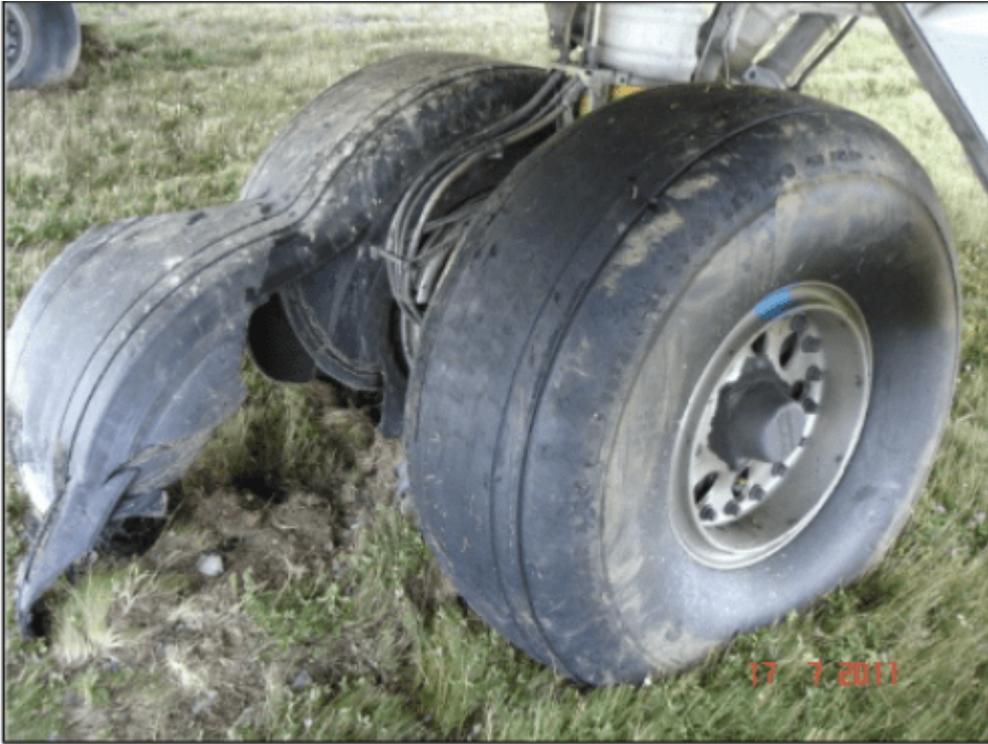
Tire damage due hydroplaning
