The Air India Express IX1344 accident at Khozikode and the ensuing investigation will focus on the deceleration devices of the aircraft, their effectiveness, the prevailing environment and the interaction with the runway surface.

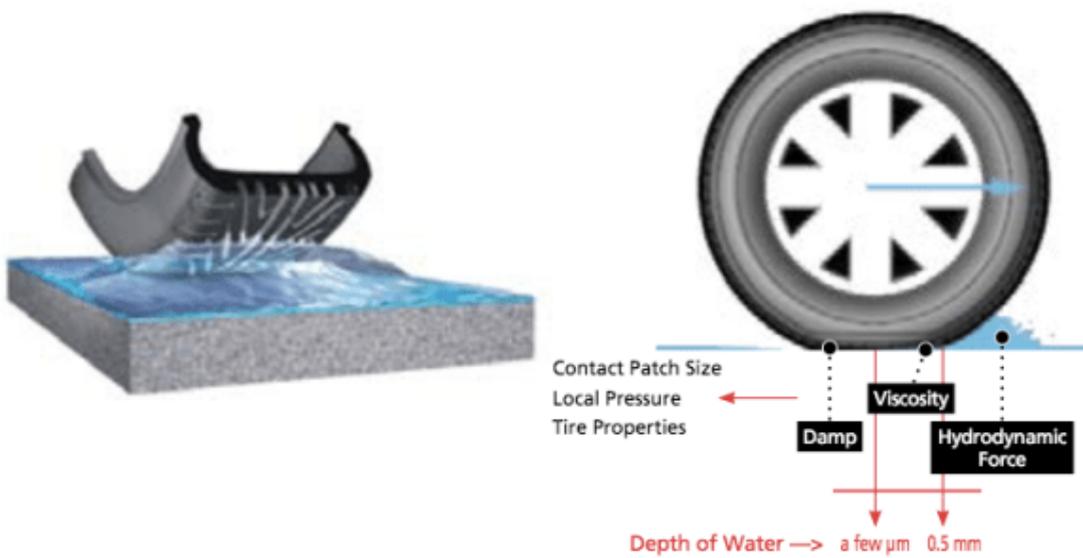
There are two types of hydroplaning.

- Dynamic Hydroplaning
- Viscous Hydroplaning

Hydroplaning

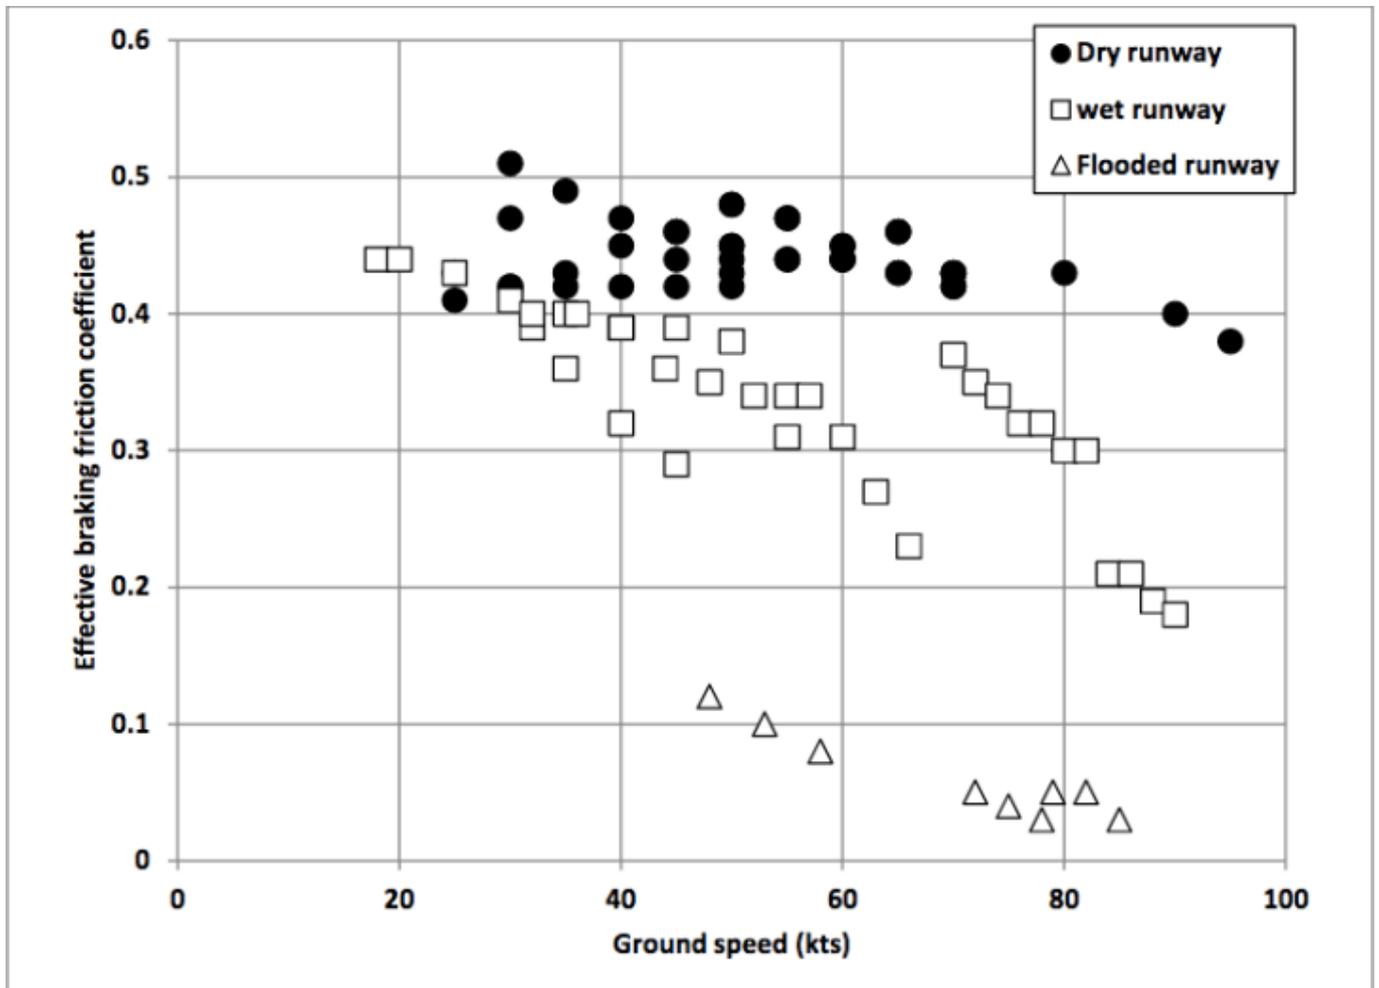
Comparison of the effective braking friction coefficient as function of ground speed on a dry, wet, and flooded runway for a B737-100(source; NASA flight tests).
