Behind the Lion Air Crash, a Trail of Decisions Kept Pilots in the Dark

The comment as posted in the NY Times on 04th Feb 2019. The entire focus of the media and public is on MCAS and how the pilots were not informed about it. The information on MCAS as a system has still not been shared with the pilots. How can we be so sure that the MCAS is installed on the Max?

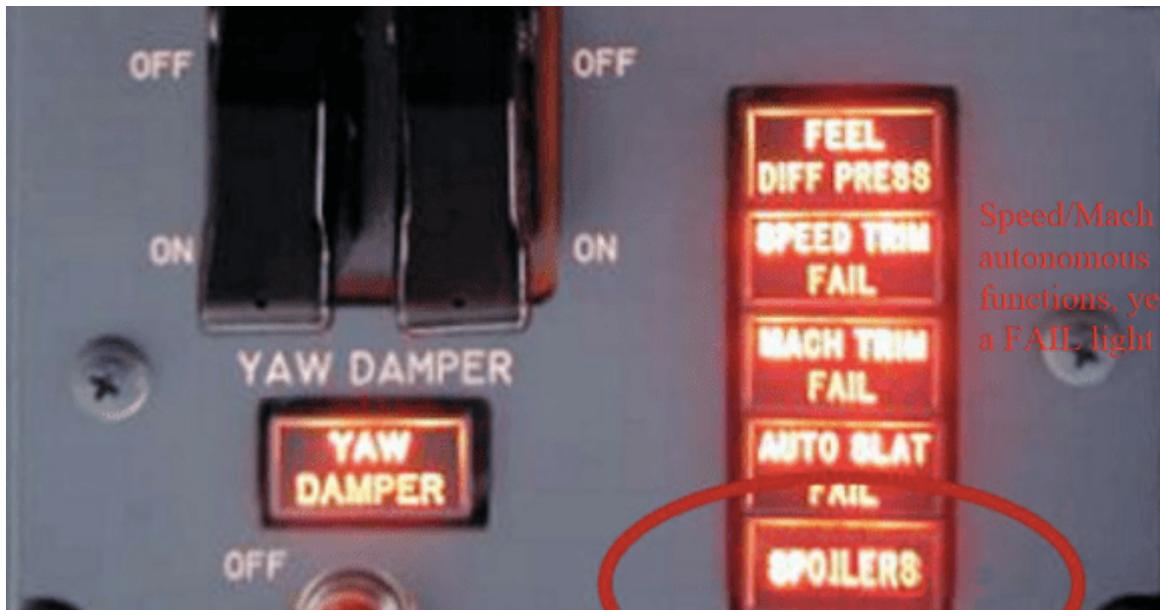
B-737 8 Max Overhead Panel

Read my blog on "B737 Safety or Ethics" published in mindFly blog "Safety or Ethics" highlighting the legal immunity that the manufacturer had enjoyed for known design defect. The same has been overturned by the court in early 2018. In the B787 battery fire incident investigations, NTSB has documented that FAA and Boeing are responsible for the defects. Design flaws led to the Battery fires: Reuters report. What we forget is that there is an existing system in the B737 called "Speed trim system (STS)" which is monitored and has a fail light.

If one channel fails, the Minimum Equipment List requires that second channel to be operational for the dispatch of the aircraft. STS also helps in automatically and autonomously, trimming down of the stabilizer if the aircraft nears a stall. How many people know that?
